## ORGANIZATIONAL STRUCTURES AND IMPROVEMENT OF THE QUALITY PROBLEM ANALYSIS PROCESS

**Abstract.** In this paper we will present the analysis method used to solve a client complaint. The analysis aims to determine the root causes that led to the appearance of the respective problem. The first step is the problem delimitation, and for this we need to recover as much information as we can from the repair shop. The main aim of this step is a better understanding of the causes that led to this problem. The next step is to analyze the existent information and all the existent references to be able to build the causal chain that could lead us to the root causes of the problem. The last step is the identification of the necessary actors that could solve the problem and to follow the application of the proposed solutions by them.

In this present paper, we intend to present a method used to identify the causes of an issue appeared at the customer level: central arm-rest does not stay in the upper position.

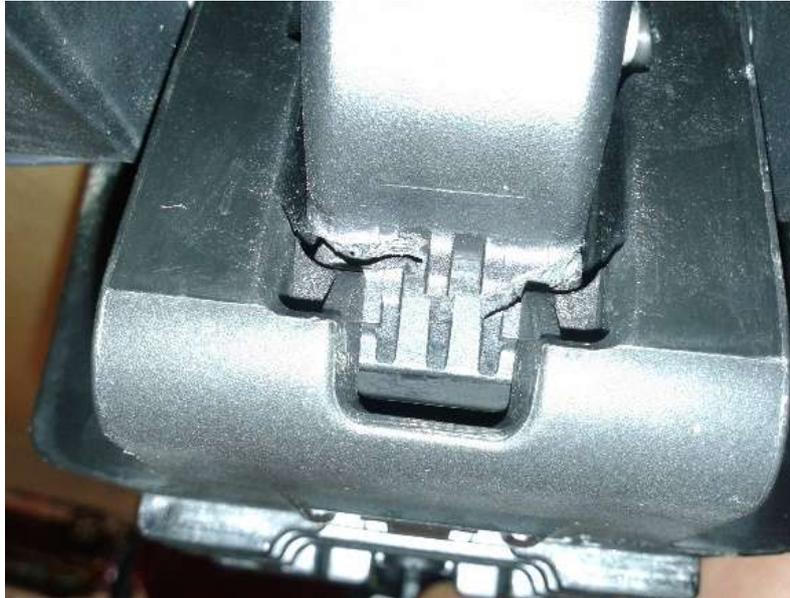
Besides the information about the mileage of the occurrence of the customer effect, the service units also sent pictures showing the area where the piece is broken (Figure 2).

**Fig. 2:** Part breaking area

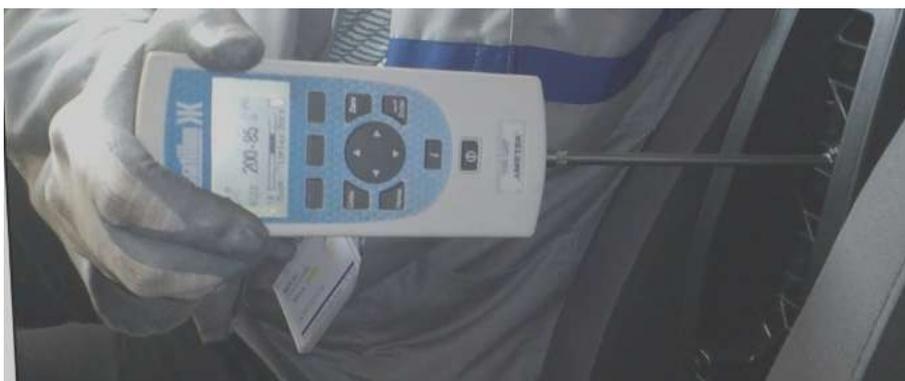
In the specifications of the part, there is an effort to break the piece in the maximum open position, its value being of 25daN for a period of 5 seconds.

Figure 5 shows how to apply the effort to perform this test.

**Fig. 5:** Carrying out the test from the specifications

To verify the strength of the parts, we tested 5 new pieces, the results being shown in Table 1.

After analyzing the data obtained in the table above, we found that the parts do not meet the requirements of the specification. Thus, the cause of the FC 1.1: Non-compliant piece in relation to the specifications is validated. The next step is to determine the causes that may lead to this problem, especially because at the initial validation of the product in accordance with the specifications the problem had not been identified.

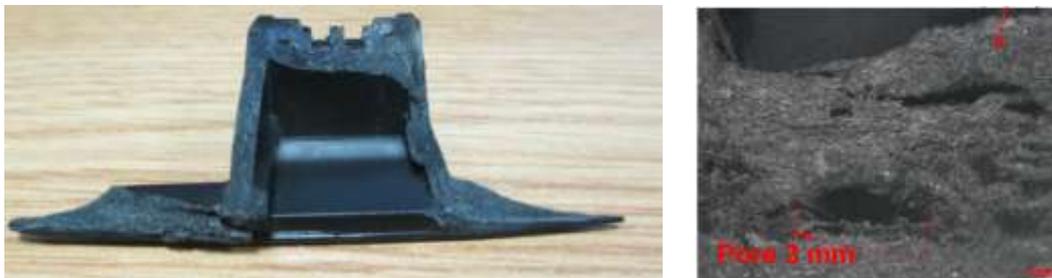
For the second Failure Under-Cause 1.1.2, Injection process non compliance, the same two parts were analyzed by the laboratory and it was found that both have internal air gap defects in the rupture priming areas (see Figure 6).

**Fig. 6:** Air gap defects in the rupture area

In conclusion, the *Failure Under-Cause 1.1.2. Injection process non compliance* is validated.
